Manhole Inspection Summary

Manhole # S07WW1011MH

Insp Date: **9/12/06 3:44 PM**

Location Address: **3000 MANHATTAN AVE**

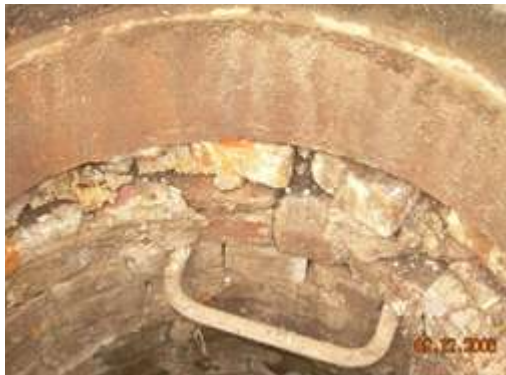
Defect

Condition: ☐ Sound ☐ Cracked ☒ **Leaks**

Condition: ☐ Sound ☐ Cracked ☐ Root Intrusion ☒ **Loose Brick** ☒ **Deteriorated**

Infiltration: ☐ None ☒ **Joint** ☐ Cracks ☒ **Mortar** ☐ Roots ☐ Wall

Frame leaks. Adjustment deterioration, loose brick, and infiltration - other side.

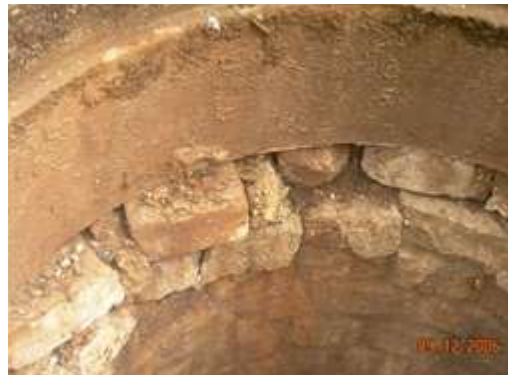
Defect

Frame leaks. Adjustment deterioration, loose brick, and infiltration.

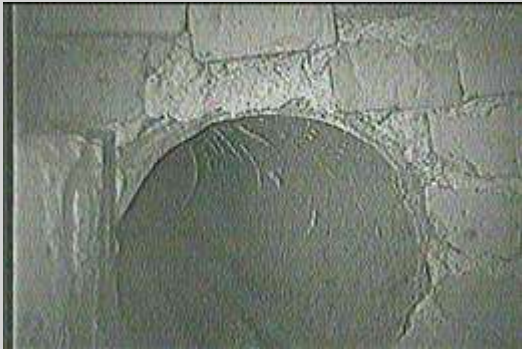
10 in. Circular Gravity Sewer Pipe Out @ 12 O'Clock

Infiltration: **Evidence** Pipe Seal Cond: **Cracked**

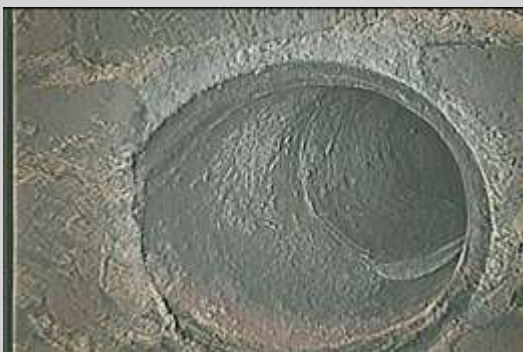
8 in. Circular Gravity Sewer

Deposits: ☐ None ☒ **Mud** ☐ Sludge ☒ **Debris** ☒ **Grease**

Silt Depth: **0** (in.) Deposits Extent: **Light**

Infiltration: **Evidence** Pipe Seal Cond: **Unknown**

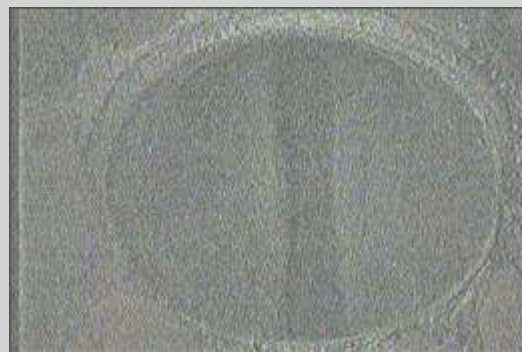
Drop In @ 9 O'Clock

Drop: **Outside** Rod and Bar

Drop Condition: **Open**
